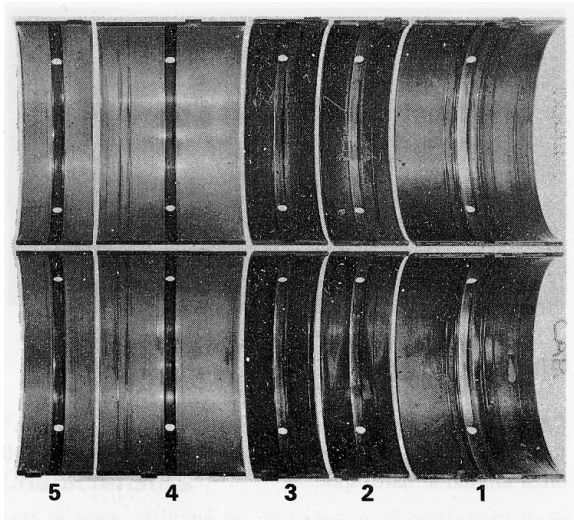
Cavitation erosion

Attack of bearing material in isolated areas, in random pattern, sometimes associated with grooves.

Impact fatigue caused by collapse of vapour bubbles in oil film due to rapid pressure changes. Softer overlay (Nos. 1, 2 and 3 bearings) attacked. Harder aluminium – 20% tin (Nos 4 and 5 bearings) not attacked under these particular conditions.

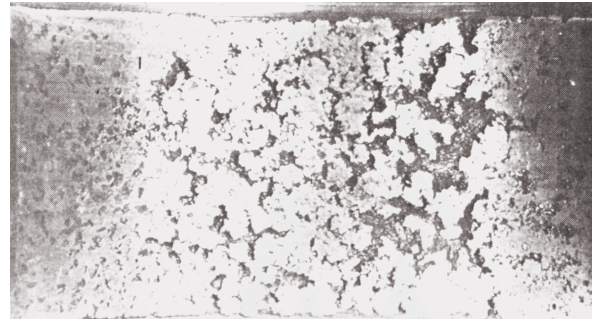
Corrosion

Removal of lead phase from unplated copper-lead or lead-bronze, usually leading on to fatigue of the weakened material.

Formation of organic acids by oxidation of lubricating oil in service. Consult oil suppliers; investigate possible coolant leakage into oil.

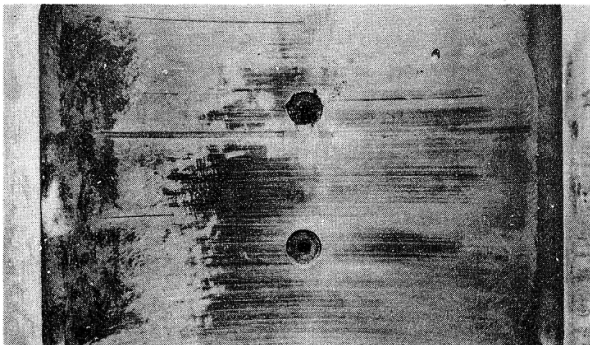
Tin dioxide corrosion

Formation of hard black deposit on surface of white-metal lining, especially in marine turbine bearings. Tin attacked, no tin-antimony and copper-tin constituents.

Electrolyte (sea water) in oil.

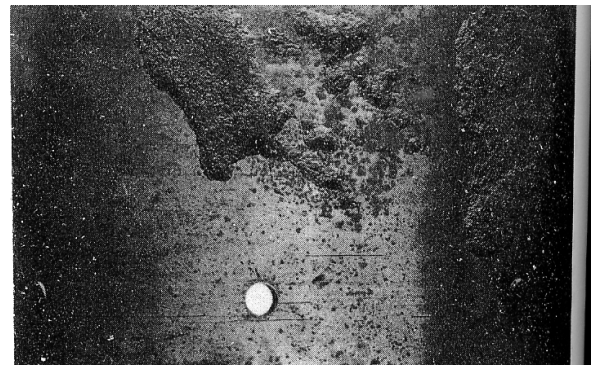
'Sulphur' corrosion

Deep pitting and attack on copper-base alloys, especially phosphor-bronze, in high temperature zones such as small-end bushes. Black coloration due to the formation of copper sulphide.

Attack by sulphur-compounds from oil additives or fuel combustion products.
